COMPDYN 2013
4th ECCOMAS Thematic Conference on
Computational Methods in Structural Dynamics and Earthquake Engineering
M. Papadrakakis, V. Papadopoulos, V. Plevris (eds.)
Kos Island, Greece, 12–14 June 2013

THE EMILIA EARTHQUAKES: REPORT AND ANALYSIS ON THE BEHAVIOR OF PRECAST INDUSTRIAL BUILDINGS FROM A FIELD MISSION

Dionysios A. Bournas¹, Paolo Negro², and Fabio Taucer²

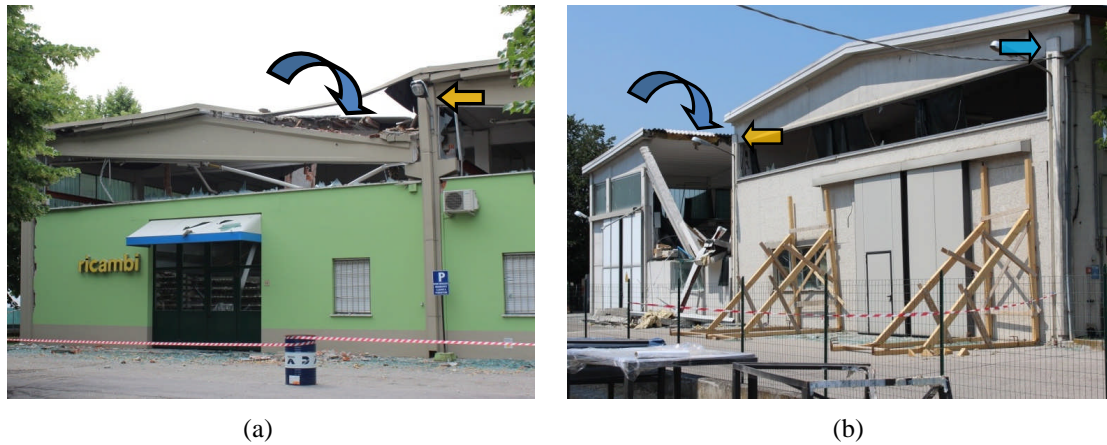
The weak link in the vast majority of the industrial buildings visited was the absence of mechanical connections between roof-girders and columns. The most common typology corresponded to double-slope beams, simply supported over special openings (forks) at the top of columns as shown in Fig. 4. This typology was used in Italy during the 60s and 70s for agricultural buildings, now being replaced by the more common flat-roof systems. In this connection typology, the capacity of transferring lateral loads depends entirely on the static coefficient of friction between the supporting surfaces of beam and column and on the length of the beam seating when the friction forces are exceeded by the earthquake force demands.

Figure 5: (a) Loss of beam seating from the central column and associated collapse of a double slope precast beam (the blue curved arrow shows direction of collapse and the orange arrow shows the intermediate beam); (b) Longer seating of the end beam at the external column (blue arrow).

In response to the risk associated with the seismic response of industrial precast buildings an ordinance comprising general guidelines for vulnerability assessment and intervention was issued by the national authorities [11]. This draft document calls for the need of adopting interventions to reduce the relative displacements between column heads and supporting beams

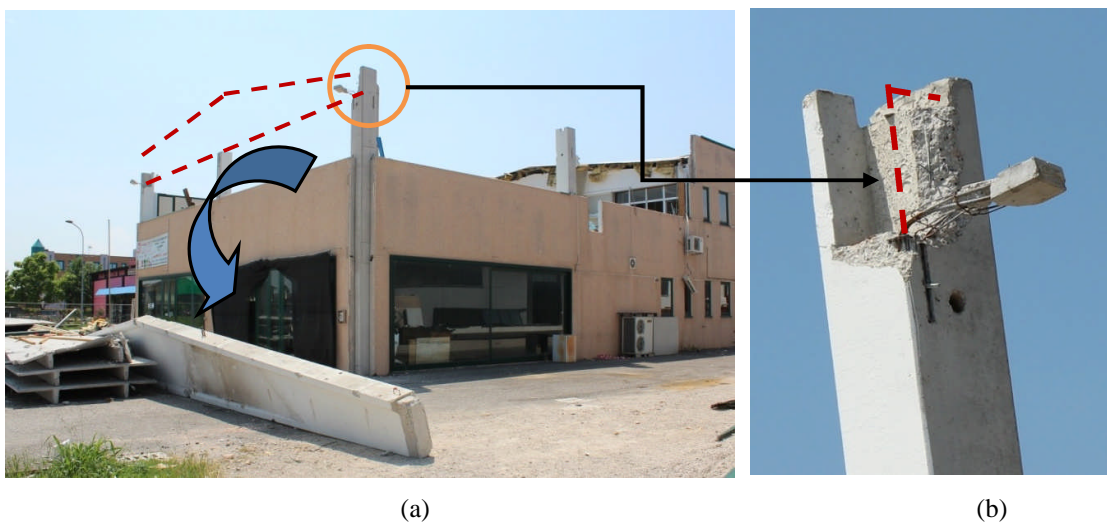
Figure 6: (a) Out-of-plane collapse of a double slope precast beam after unseating following failure of the lateral restraint of the fork at the seat pocket; (b) Detail of the shear failure of the fork.

- The weak link in the majority of industrial buildings designed with no seismic provisions only was the absence of a mechanical connection between beams and columns. This resulted in a large number of collapses induced by unseating of the main beams. The loss of seating occurred mainly in the central columns, where the seating length of the girders was rather limited. In other cases the collapse of girders took place in the out of plane direction – of the girder – following failure of the lateral restrains at the top of the column.

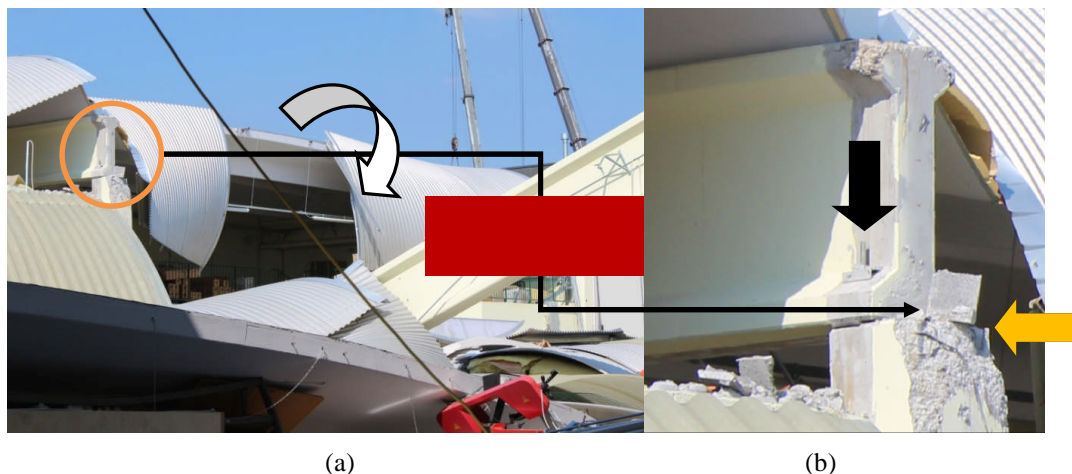
It is worth mentioning that a building completed in 2010 showed partial collapse, in spite of having been designed (according to information provided by the owner) with pinned beam-column connections following the new Italian construction standards. Visual inspection revealed failure at the top of one of the central column beam-column connections. This failure was followed by loss of the girder seating and its subsequent collapse (Fig. 7a). The rather limited distance of the dowels from the edge of the column and the limited amount of transverse reinforcement might have resulted into the formation of a shear crack across the concrete cover (Fig.7b), followed by the loss of the dowels anchorage and consequently the loss of the girder seating. This failure reveals the absence of specific provisions for detailing the beam-to-column connections in the current Italian construction standards and the as well as in the Eurocodes [10].

Figure 7: Loss of girder seating in a recently constructed industrial building after failure of the pinned beam-column connection: (a) General overview of the collapsed beam (red dashed lines); (b) Detail showing failure of the column support at the beam-column pinned connection. Orange arrow shows damaged area at the top of the column, while red arrow shows an undamaged pinned connection.

Based on the work of Psycharis and Mouzakis 2012 [20], a rational procedure for the seismic design and proper detailing of pinned beam-to column connections was proposed. Following the concept of Eurocode 8, the connections are overdesigned with respect to the strength of beam and column. The prevailing energy dissipation mechanism of the structure relies on the formation of plastic hinges within the critical regions of the columns, with the connections remaining elastic. The design of the columns is based on a prescribed force reduction factor q , whereas the design of the connections follows the capacity design rule: the design shear force E_d for the connection is obtained assuming that the ultimate flexural resistance is developed at the base of the column, calculated by multiplying its flexural resistance M_{Rd} by the overstrength factor γ_{Rd} . Verification for the shear resistance of the connection R_d is made, namely by satisfying the inequality $E_d \leq R_d$. On the basis of the experimental results obtained by Psycharis and Mouzakis 2012 the following formula for the shear resistance of the connection was proposed:

- It was suggested to use a sufficient cover of the dowels ($d/D \geq 6$), otherwise spalling might occur, which much decrease their resistance.
- The presence of horizontal hooks in front of the dowels was found to be very important for the hinged joint's seismic response.
- The use of high strength grout inside the sleeves increases the resistance of the connection and improves its cyclic response by decreasing pinching and increasing ductility.
- For flexible columns, large rotations can occur at the joints, which reduces shear strength and increase damage to the connection, which increases with repeated cycles.

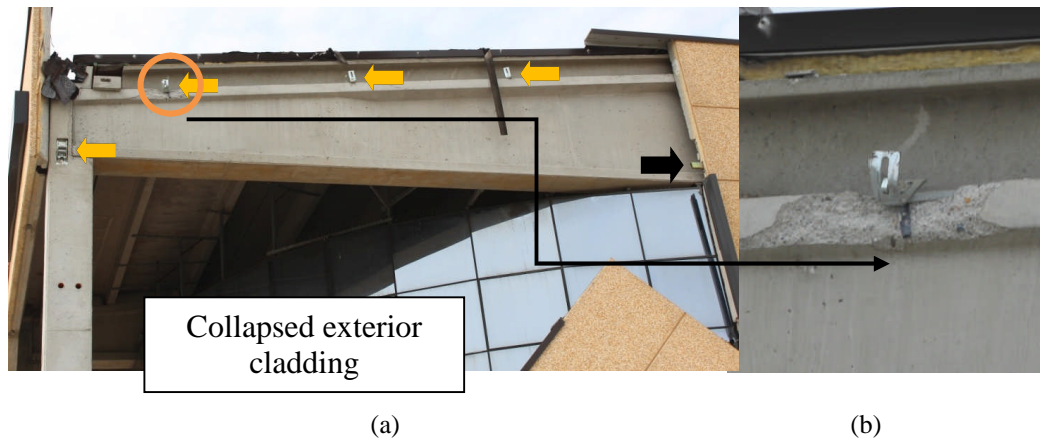
Figure 8a illustrates the in-plane detachment of an exterior cladding element after failure of the connections (Fig. 8b) with the main structure. The design of the claddings connections proved to be insufficient also in the orthogonal direction. The out-of-plane inertial effects of the panel led to the development of high out-of-plane lateral forces that induced failure in the panel-to-frame and panel-to-panel connections.

Figure 8: (a) Cladding panel collapse after failure of the connections with the main structure (orange arrows showing the location of connections of the collapsed exterior cladding); (b) Detail showing failure of the mechanical connection.

The detachment of the cladding panels from the main structure due to the insufficient capacity of the connections was practically not improved in the newly constructed buildings. The panel connections were designed to transfer the vertical load of the panel, as well as any out-of-plane loading, to the precast structure, allowing for free deformations along the other directions. There were two types of loading situations for which the panel was not designed for: i) excessive drifts that exhausted the fastenings sliding capacity and led to the development of high forces and fracture of the fastenings; and ii) high out-of-plane inertial forces that led to the fastenings failure.

tribute to seismic response, stringent design criteria for the design of the connections should be enforced: connections devices should be able to provide the required strength in the vertical and out-of-plane directions while accommodating large relative deformations in all other directions (Figure 11a). A viable option would be to prescribe adequate fail-safe restraints, so that the panels would not fall even in case the relative displacement capacity of the connection is exceeded (Figure 11b). Another possibility would be to design the claddings and their connections as being an integral part of the structure, by adequately taking into account their strength and stiffness in the design model. These are the objectives of the recently activated EU-funded project SAFECLADDING (Grant Agreement no. 314122).

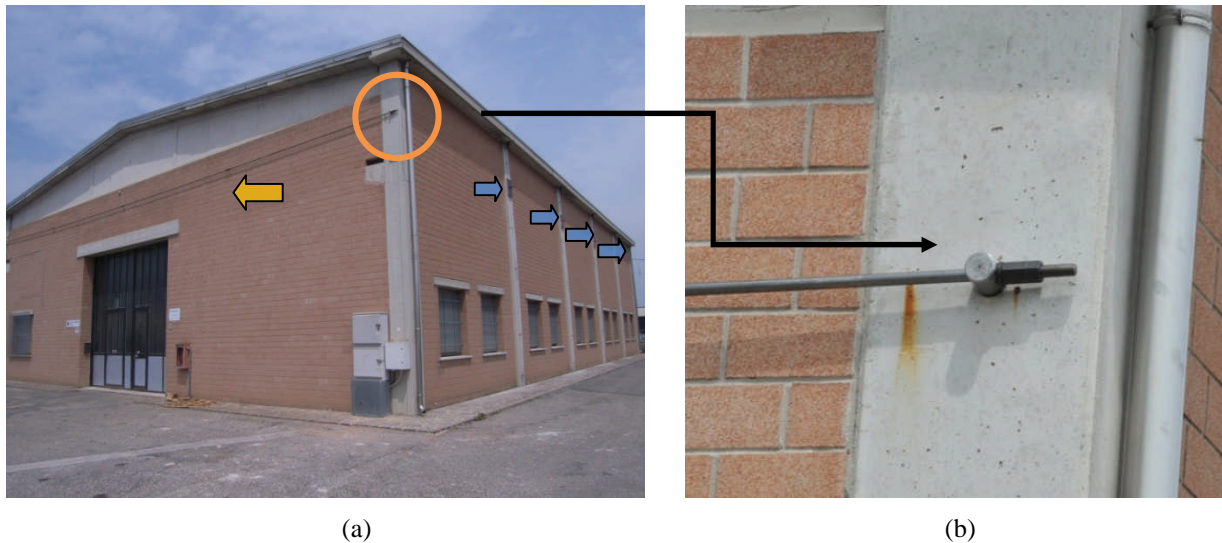
During the field visit the team inspected a precast industrial building that had been retrofitted following the first event (after information gathered from the building owner). The building corresponded to the typology with simply supported beams on columns designed for gravity loads only. The retrofit consisted in a series of steel ties in line and below the main girders, as shown in Fig. 9. The steel ties were anchored at the top of the columns in the transverse direction and might have prevented opening of the columns and loss of seating of the girder during the 29 May event.

Figure 9: (a) Steel ties anchorage system installed after the main event to stabilize the structure: orange arrow showing the external tie, blue arrows showing the internal ties. (b) Detail of the anchorage at the external tie.
